# Manhole Inspection Summary

Manhole # S53E\_\_012MH

Insp Date: **4/29/08 10:38 AM**

**Location** Address: **10 s highland ave**

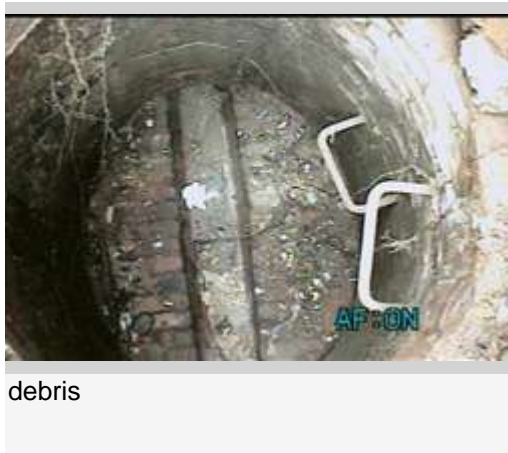
misc

debris

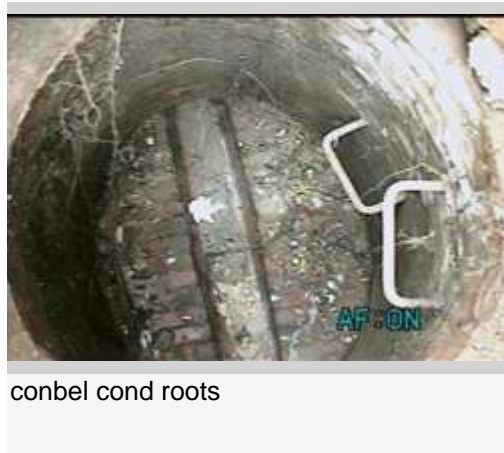
Defect 1

Condition: ☐ Sound ☐ Cracked ☒ **Root Intrusion** ☐ Loose Brick ☐ Deteriorated

conbel cond roots

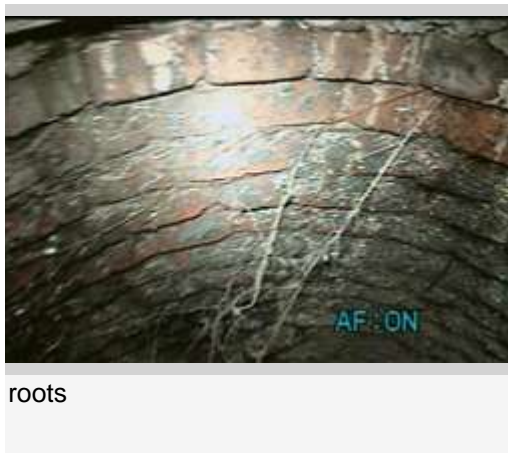
Defect 3

roots

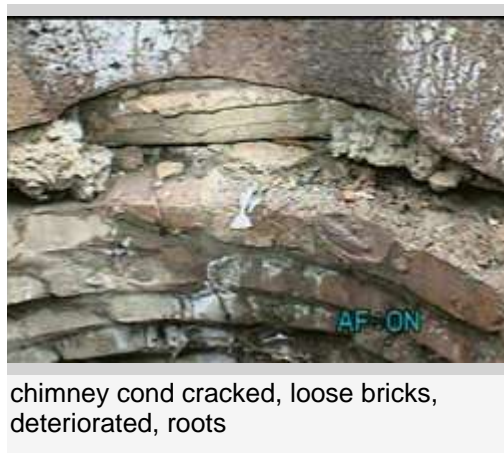
Defect 2

Condition: ☐ Sound ☒ **Cracked** ☒ **Root Intrusion** ☒ **Loose Brick** ☒ **Deteriorated**

Infiltration: ☐ None ☐ Joint ☐ Cracks ☐ Mortar ☒ **Roots** ☐ Wall

chimney cond cracked, loose bricks, deteriorated, roots

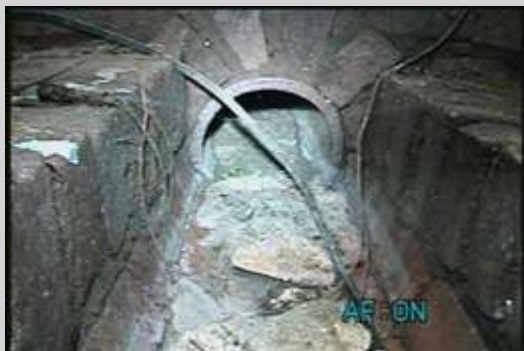
6 O'Clock Inflow

Deposits: ☐ None ☐ Mud ☒ Gravy ☒ Debris ☐ Grease

Silt Depth: 2 (in.) Deposits Extent: Medium
